# Environmental Audit

## Stirling City Centre Go Forth Stirling Business Improvement District

February/March 2024

Auditor: Alexander Stevenson, Environment and Place Services Officer, Keep Scotland Beautiful

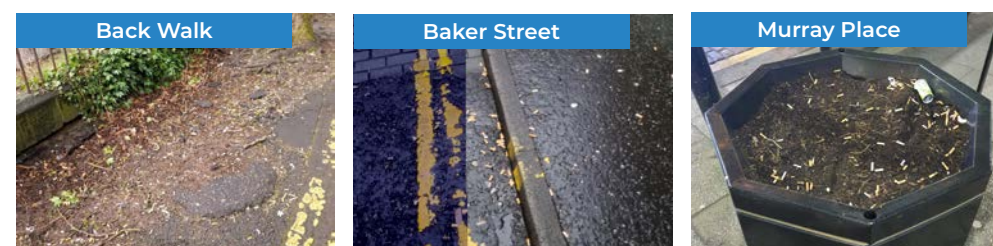
Figure 6: Smoking related litter counts

The most common form of litter identified during the audits was smoking related, with this found in almost all (95.6%) of audited sites and making up 74.0% of individual litter items encountered. Overall, 4,195 small items (almost all cigarette ends) were found, with 51 larger items of smoking related litter found, an average count per 100m<sup>2</sup> of 46.7.

Tackling smoking related litter and the behaviour surrounding it is therefore one of the clear challenges to be addressed moving forward. Trends identified relating to where it was found included; it being discarded in disused areas, discarded around bins with effective apertures, along hard edges of buildings or at junctional areas, into areas of accumulated waste or detritus. Moreover, there was an abundance of smoking related litter found within planters of varying sizes, on Murray Place, Station Road, and King Street.

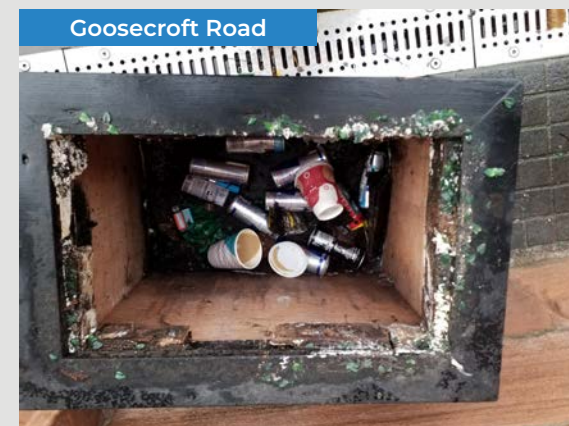
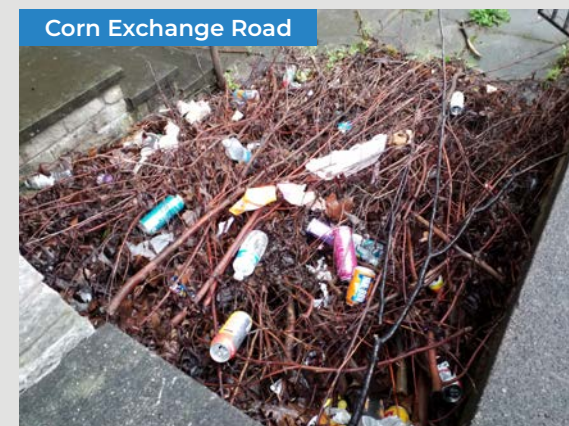
This pedestrian walkway linking Dumbarton Road to Corn Exchange Road has seen a significant accumulation of smoking related litter. This could be to do with its proximity to a public house/restaurant or to do with the encroachment of detritus and natural debris which has gathered. The levels of discarded litter here were, for such a small site, concerning, with ownership for this needing to be taken by either council or business authorities. It was noted here that there was only one small bin able to be used for the appropriate disposal of cigarette waste.

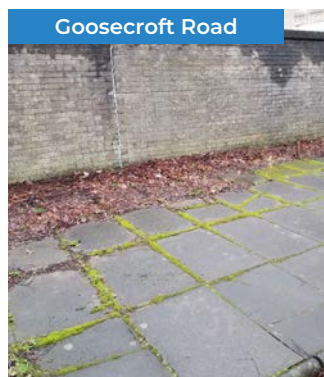
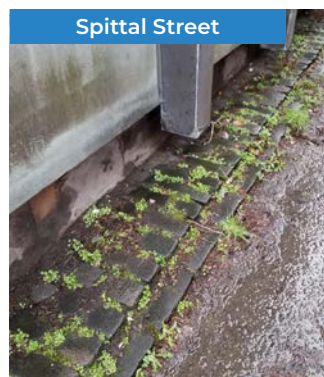
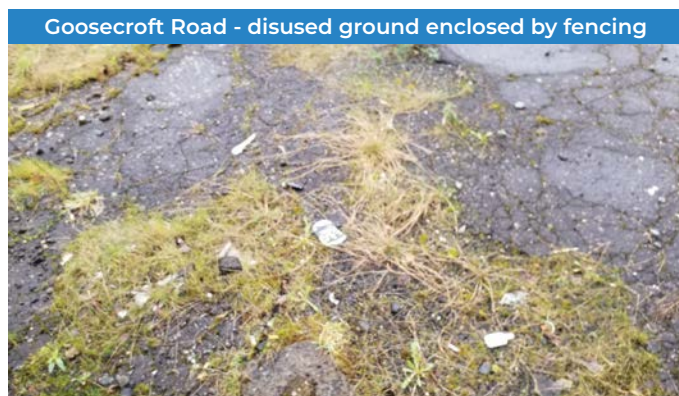
Images of weed growth

The audits conducted also revealed that of the 91 sites visited, **39.6%** had no visible presence of weed growth, with **46.2%** displaying a minor presence. There were 13 sites in total with a significant to severe presence of weed growth, amounting to **14.2%**; only one site, again located along Goosecroft Road was highlighted as severe. Figure 7 evidences that the majority of these sites were located within study areas 3 and 5, and with the exception of Goosecroft Road and the car park in study area 2 were situated within side streets or lesser travelled public areas. These streets may be less accessible for maintenance vehicles or less frequently inspected, and it is worth noting that cobbled streets such as Spittal or Bank Street, were also subject to this weed growth.

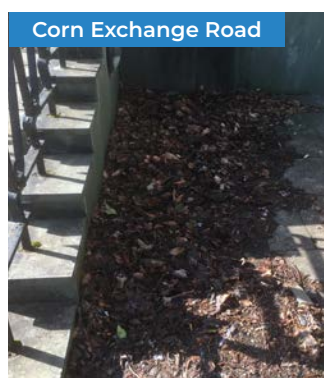
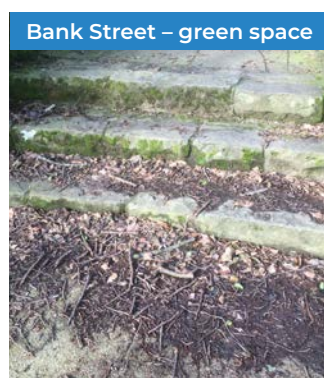
Images of detritus

The presence of detritus was also demonstrated through the auditing process with 49 sites, **54.4%**, having a minor presence, and a further **5.6%**, 5 sites having a significant presence. The remaining **40.0%**, 36 of the 91 sites had no presence. As evidenced from figure 8, sites with a significant presence were isolated to the periphery of the study areas or within side streets which will receive less footfall throughout the day. As such, they may not be experiencing the same levels of servicing or maintenance as more central or historic areas of the city.

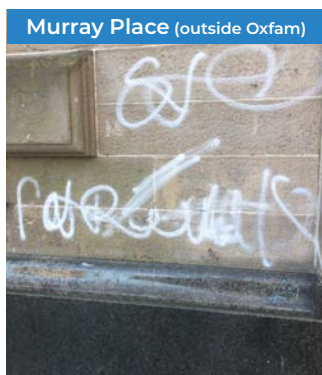
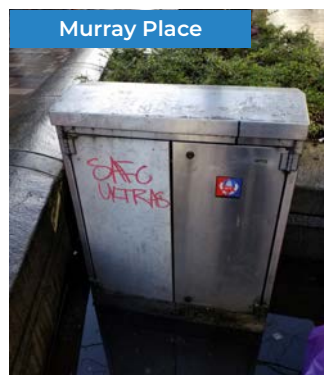
Images of graffiti

Generally, the percentage of sites affected by vandalism, flyposting and graffiti was low, which is promising to find in the BID area. Flyposting was found to be present in only 8 sites, **8.8%**, with a further 26 sites examined having a minor presence of graffiti, **28.6%**, and 1 significant presence, **1.1%**. This is favourable to find, and it was noted that this graffiti was largely confined to study area 1.

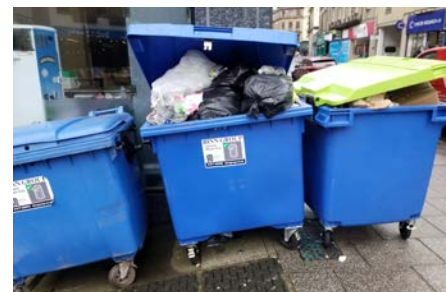
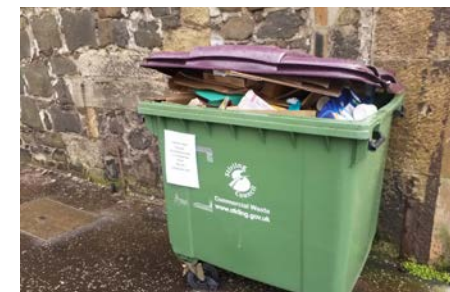
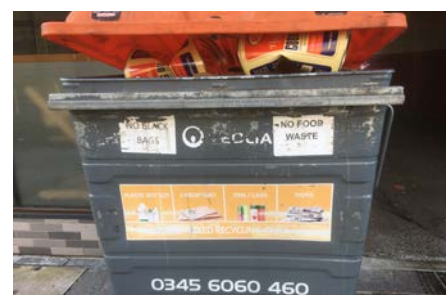
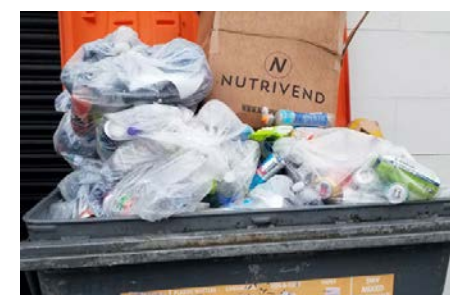
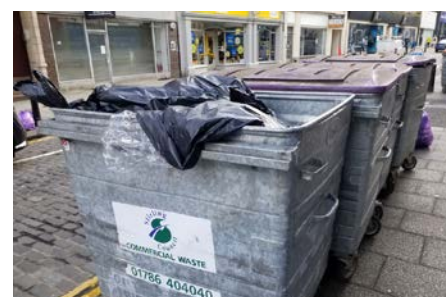
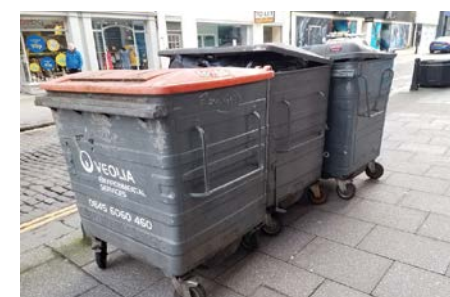
It was observed that the vast majority of bins encountered were not locked, and on one occasion a bin required a lid. The lack of these features, as raised earlier, could result in bad practice, negative behaviour impacts or the dispersal of waste. As has been seen in recent months, adverse weather conditions have the potential to impact on waste collection and street hygiene.

Evidence of bins overflowing, with no lids, insecure with no locks.
